"Tool Change Analysis"

Performed by: Rachael Rosko Intern, FCA; Dundee Engine Plant Date: 5/16/16 - 7/14/16 Supervisor: Bob Foglesong Mentor: Peter Medrano Project Heads: Mik Kovac, Tony Denouden Acknowledgments: Tania Pratniki – Plant Manager Mik Kovac – Product Engineer Tony Denouden – Product Engineer Gregory Thompson – Quality Center Manager Mike Rhode – Resident Engineering Manager Larry Smith - Block Line Team Member Ernie Woda – CMM Lab Chris Brush – Central Engineering Lead, Block Machining Randy Dickerman – Resident Engineer Engine Assembly Deandre Martin – Gage Lab Technician Casey Schiller – Block Line Team Member Todd Palenske – Block Line Team Leader

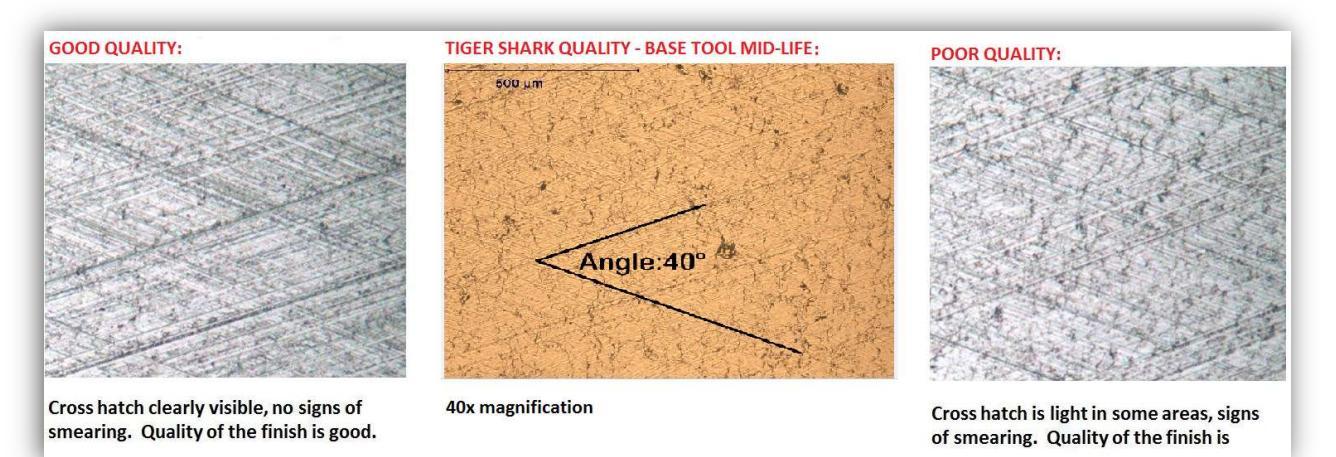
Figure 8 - Fax Film Comparison: Base Tool Mid-Life

The results found, as pictured below in Figure 8, conclude that the quality of the cylinder bores produced by the base tools had noticeable torn and folded metal with unclear

In Figure 8, the "Tiger Shark Quality" box looks closer in comparison to the "Poor Quality" box. This is because the "Tiger Shark Quality" picture has unclear crosshatch angles and smeared looking consistency. Note that the Tiger Shark image is at 40x magnification and the magnification of the good and poor quality pictures are unknown. This is solely qualitative data, any attempt at quantitative data via fax films must be paired side by side to SEM pictures, dyno tests or other similar methods.

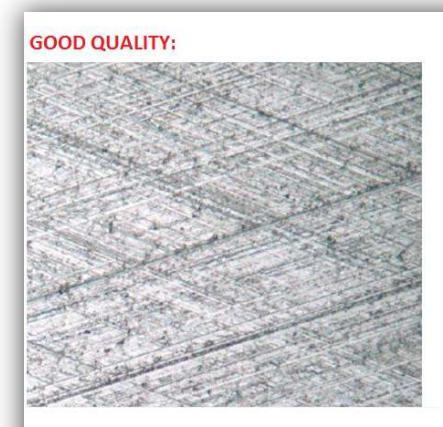
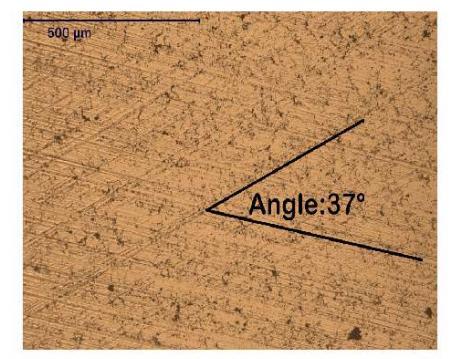
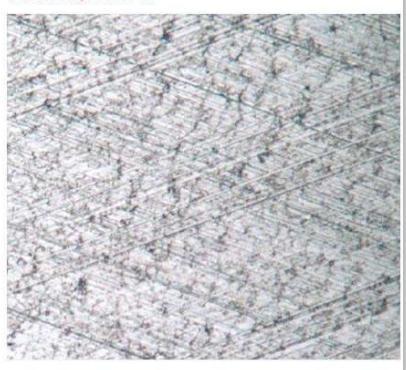
Figure 9 - Fax Film Comparison: Tool Change Mid-Life

Cross hatch clearly visible, no signs of smearing. Quality of the finish is good.

TIGER SHARK QUALITY - TOOL CHANGE MID-LIFE:

Cross hatch is light in some areas, signs of smearing. Quality of the finish is poor.

In comparison to Figure 8, the "Tiger Shark Quality – Tool Change" image is of better quality. Notice it looks closer in correlation to the "Good Quality" image. The crosshatch angles can be more easily spotted and there appears to be less smearing though not perfect. Discretion must be advised in comparing pictures as it is sometimes better analyzed by a professional; in this investigation, we will assume caution with the "Tiger Shark Quality – Tool Change" image as it seems sharper, but may be too sharp for piston rings and may not be the desired quality. A better comparison is seen through the profilometer scans and readings (described later on).

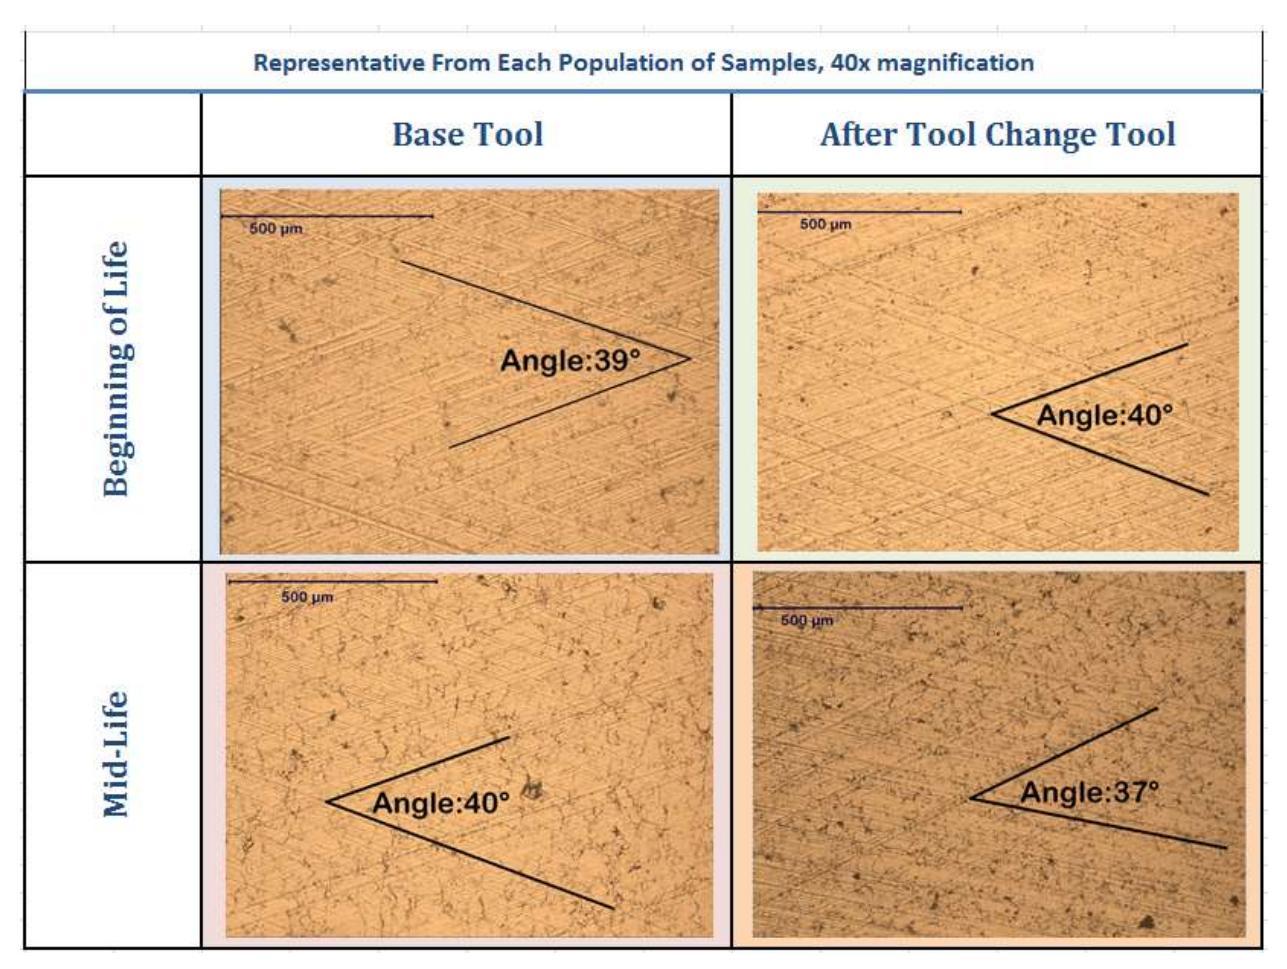
Figure 10 - Fax Film Comparison: All Sets

Figure 10 compares all four sets of data with each other: the beginning and middle of each tools life in relation to the base and after tool changes tools. The results produced by the middle of each tools life is important to observe as it is representative of the average quality that the tool will give. As shown in Figure 10, the base tool starts out looking clear and has clear cross hatch angles then wears and produces lower quality over time with more smearing and less clear cross hatch angles. From fax films alone, the after tool change tool appears to have better and more consistent quality in that the cross hatch angles and images themselves are sharp and clear both at the beginning and middle of the tools life.

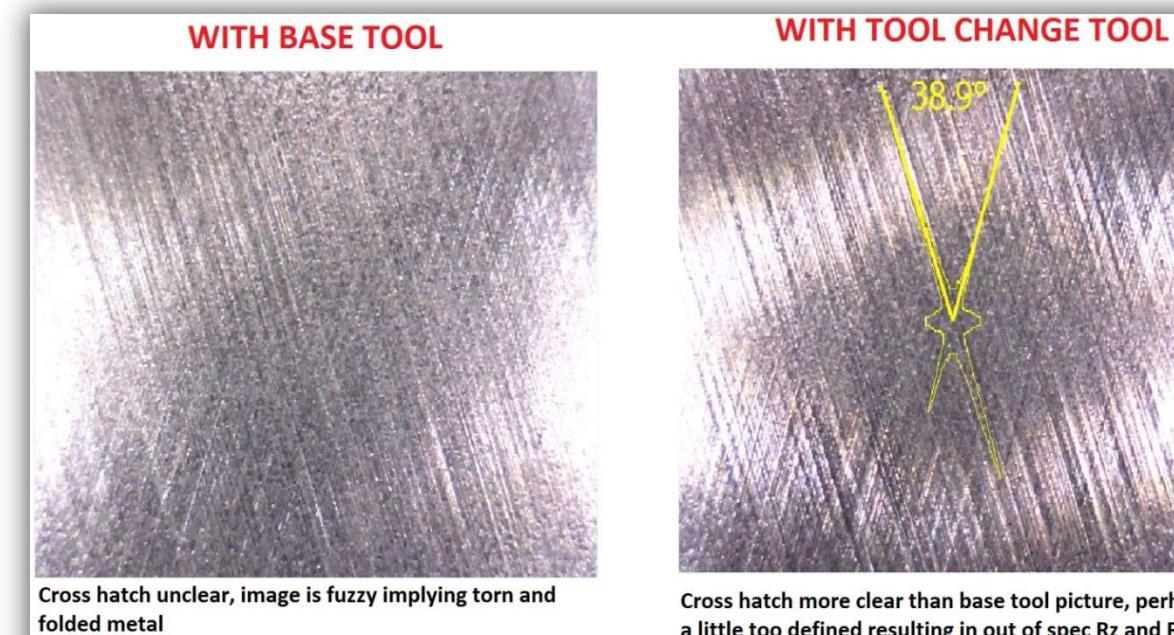
Figure 11 - Camera Images of Bore, Mid-Life Tools

The camera images taken directly of the bore reiterate the same conclusion – the bore quality appears to be sharper and has less smearing with bores honed with the after tool change tool. This is seen topographically in Figure 11 and Figure 12 below:

Cross hatch more clear than base tool picture, perhaps a little too defined resulting in out of spec Rz and Rk values

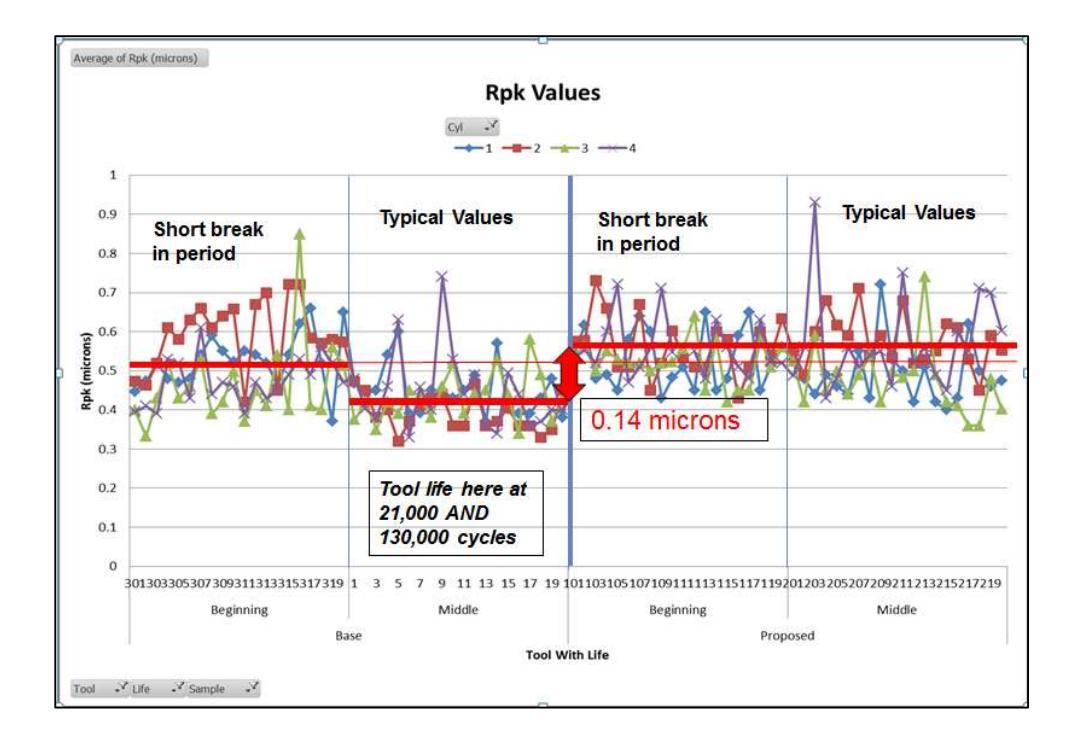
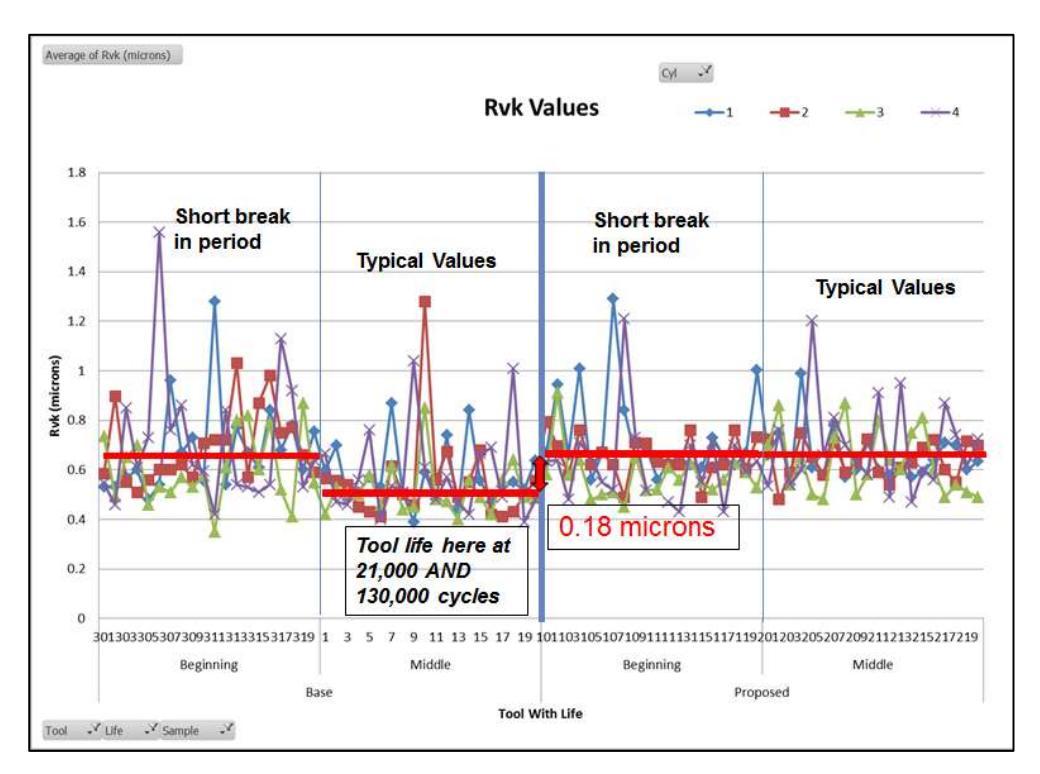
Figure 13 – Rpk and Rvk Value Comparison

The Rz and Rk value trends differed between the two tools but were fairly consistent within each similar honing tool over time. Figure 13-15 depicts the comparison between the base and proposed tool during the entirety of their lives. The Rpk, Rvk, Rz, and Rk values of the bores after the tool change are higher in comparison overall to the values of the bores from the base tool. The trend is continuous over all of the roughness values that the base tool depreciates in quality and roughness over time while the proposed tool keeps a consistently rough quality. Rpk and rvk values are crucial to piston wear and oil flow (Figures 14 and 15). Rpk refers to the peak height whereas rvk refers to the valley depths. The peaks will collide with the piston as it is shoved into the bores and when the engine starts to run. The peak heights determine how much the piston rings will end up wearing down in the initial engine break-in period. Extra wear on the rings can cause small gaps or dents in the piston that allow excess oil to pass through into the combustion chamber. The valleys, or how deep the indents are in the crosshatch, determine how much oil is retained in the cylinder bore during operation. The deeper the valleys, or higher the rvk values are, determine how lubricated the piston is. Typically the more lubricated the bore is, the less friction there is between the piston rings and bore, meaning the engine doesn't have to do as much work and can run more efficiently.

Totaling up the average increase in roughness, the proposed tool generates an average 0.6-1 micron increase. This concludes that the surface finish is measurably rougher due to the proposed tool. This is a good peak finish, not a plateau finish.

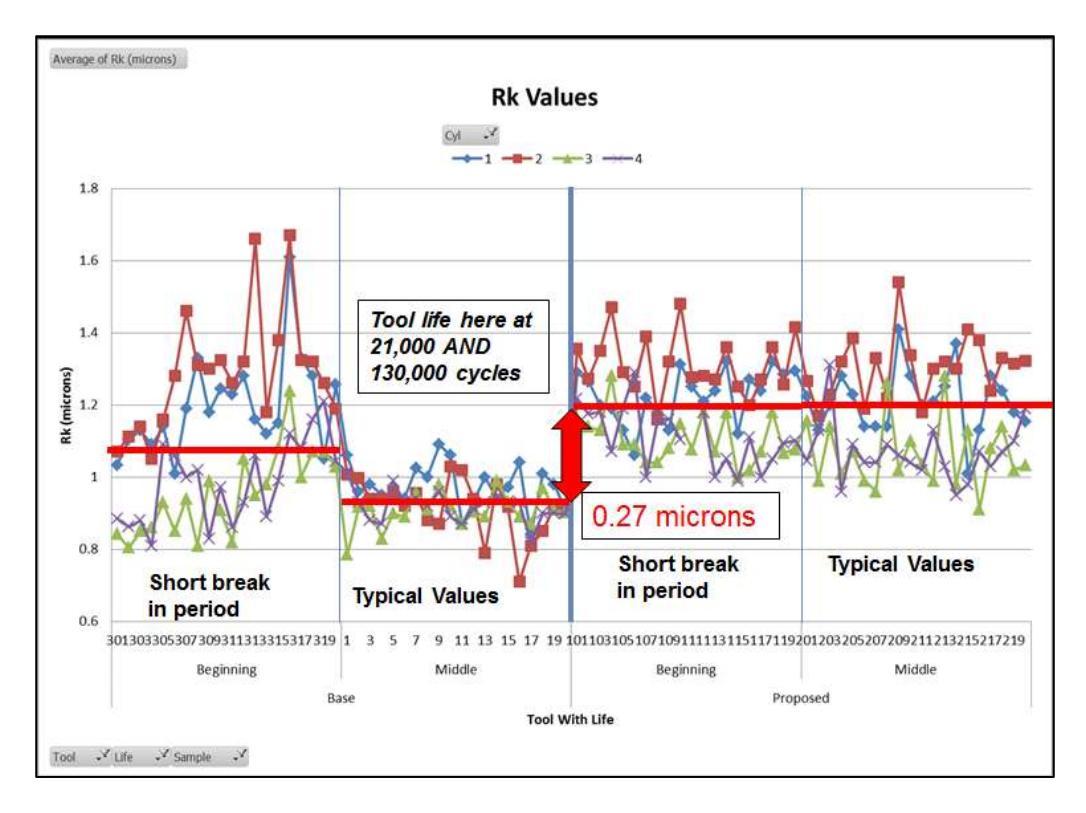
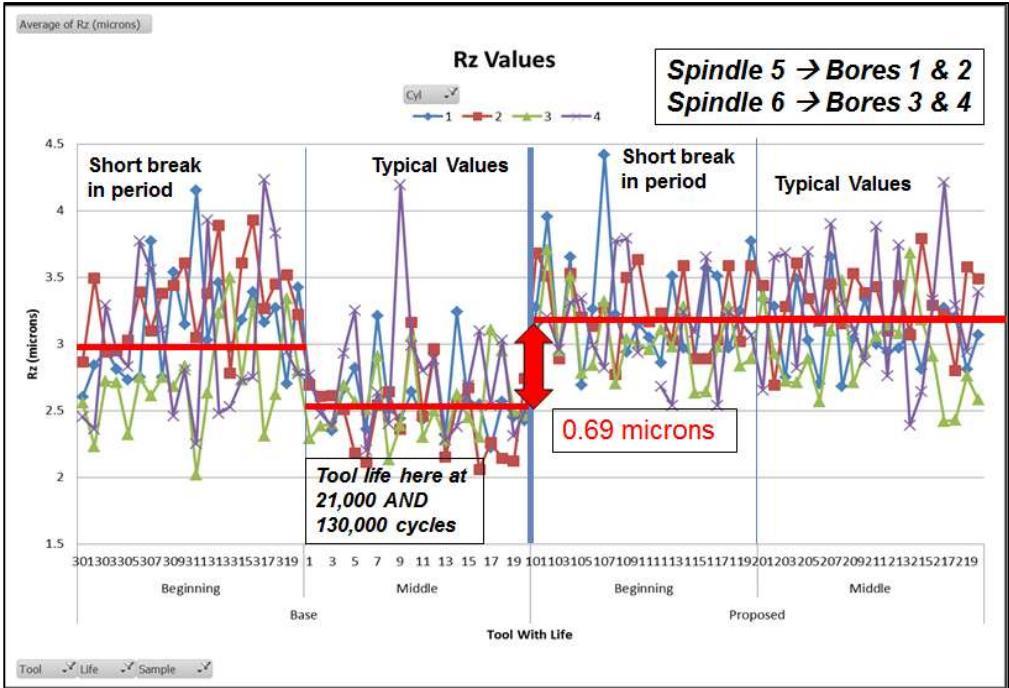
Figure 14 – Rk and Rz Values

The Rk values in Figure 14 are interesting in that spindle five seems to operate differently than spindle six. Spindle five hones bore's one and two, while spindle six hones bore's three and four. The red and blue data values associated with bores one and two are consistently higher and closer together than the green and purple data values. This confirms some small discrepancies within the machine settings. Mr2 values were continuous and within specification (Figure 15).

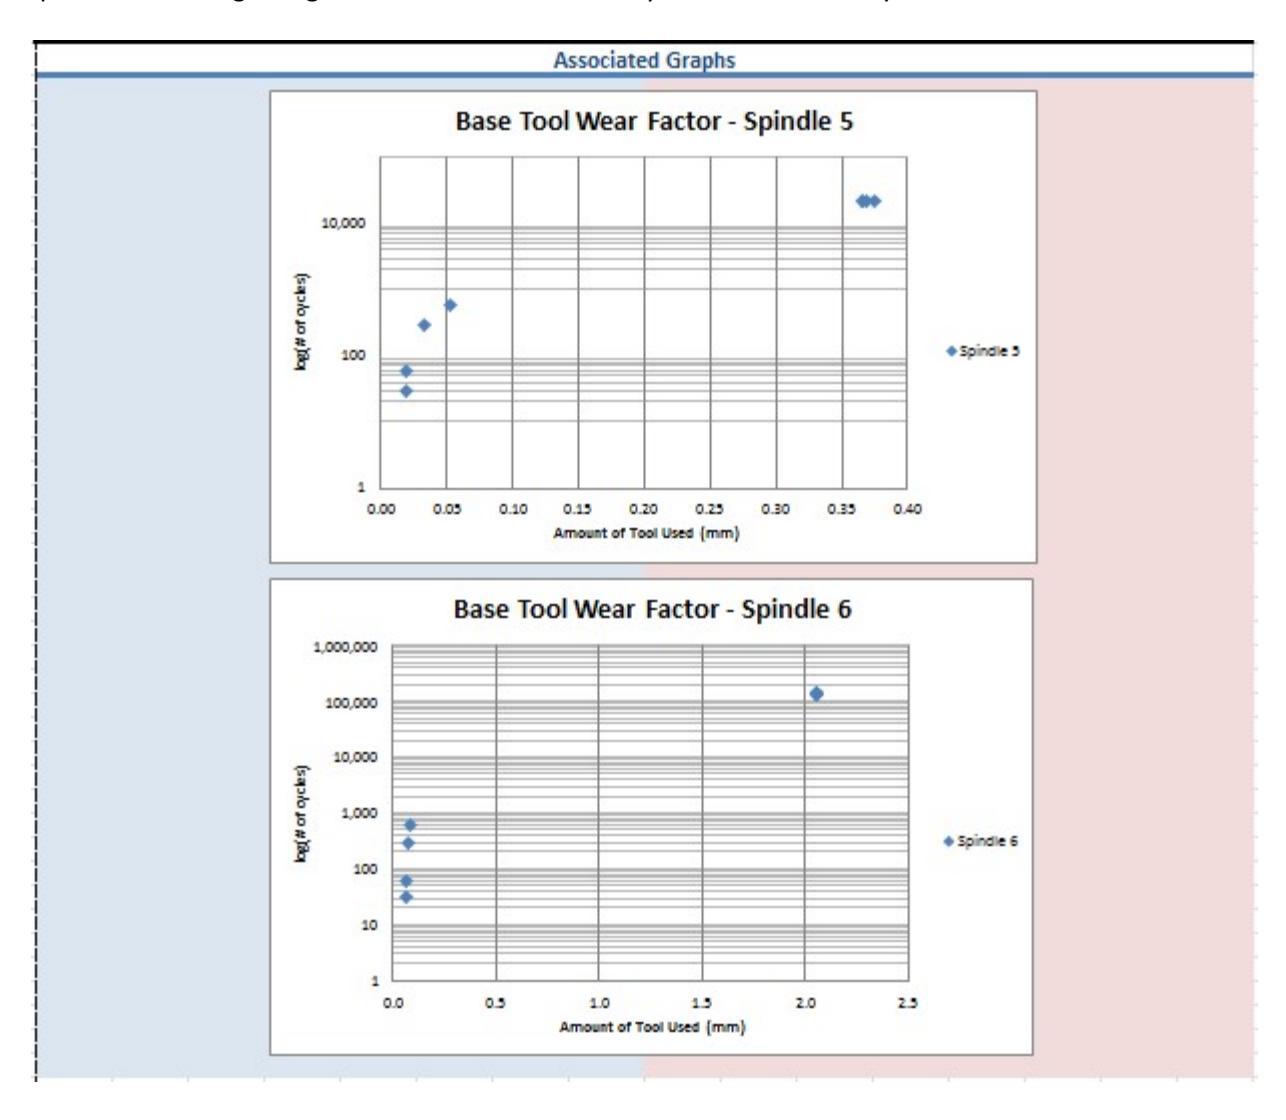
Figure 18 - Wear Factor Graph, Consistency in Wear for Base Tool

As demonstrated in Figure 18 and Figure 19, both the after tool change tool and base tool wear quicker at the beginning of their lives than after they have had a few days to break in.

A logarithmic graph is shown to better reiterate that the tool wears faster when it is first installed on the machine than when it is has been broken in. The slope of the graph appears to start steeper and plateau out past 1,000 cycles into its life.

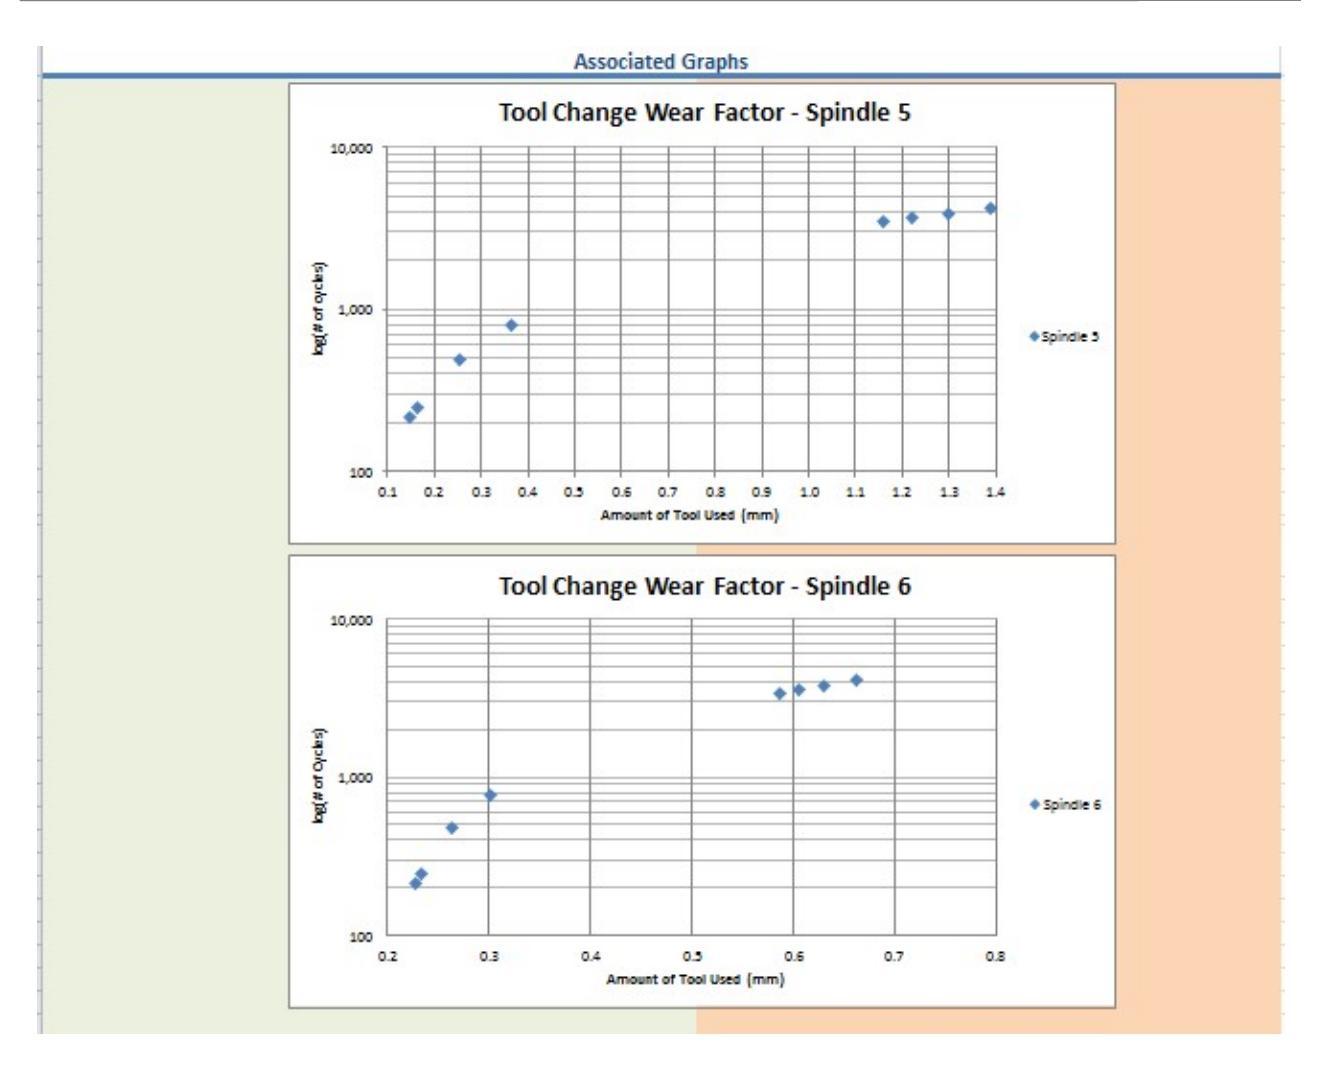
Figure 19 - Wear Factor Graph, Consistency in Wear for Tool Change

Figures 18 and 19 show that the after tool change tool wears very quickly compared to the base tool. This is shown in that the plateau values for the after tool change graphs (Figure 19) approach 0.8mm-1.4mm of tool used (of the 3mm total amount of tool) while on the y-axis only approaching about 10,000 cycles. That means that the after tool change tool has already used about a third to a half of its life within the first 10,000 cycles (or 5,000 blocks) performed. This is compared to Figure 18 where the base tool exceeds performing 100,000 cycles while still having ample amounts of tooling left.

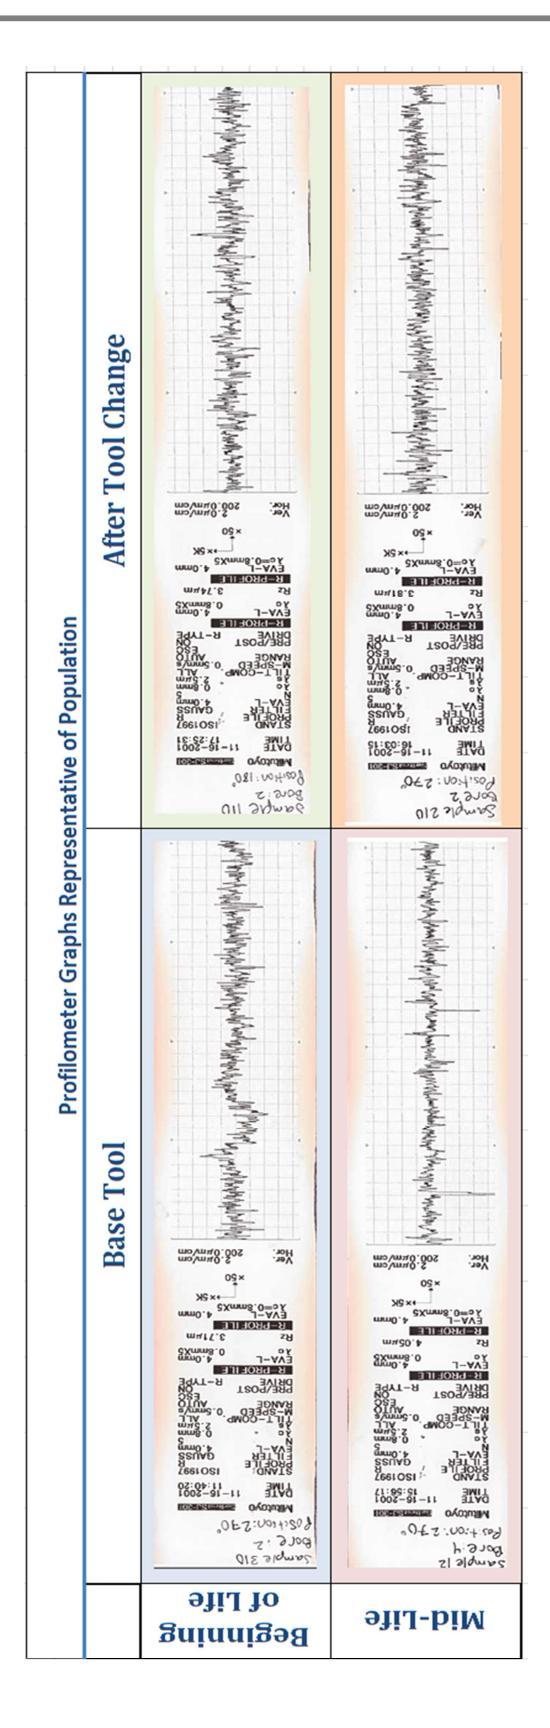
Figure 22 - Profilometer Scans Comparison

Figure 22 compares all four representative sets with one another: quality produced by the base and after tool change tool at the beginning and middle of their lives. The peaks point towards the words "Base Tool" and "After Tool Change" while the valleys are pointed the other way. In both instances, the beginning of the tools life produces a more jagged quality with deeper valleys and higher peaks than the middle of the tools life. Comparatively, the base tool appears to maintain lower Rk values throughout its life than the after tool change tool; this is also proven from Figure 13. This potentially implies that the quality the base tool produces doesn't allow the engine to retain as much oil as the after tool change tool does. This is assumed because the valleys are shallower in the images from the base tool.
