"Tool Change Analysis"

Performed by: Rachael Rosko Intern, FCA; Dundee Engine Plant Date: 5/16/16 - 7/14/16 Supervisor: Bob Foglesong Mentor: Peter Medrano Project Heads: Mik Kovac, Tony Denouden Acknowledgments: Tania Pratniki – Plant Manager Mik Kovac – Product Engineer Tony Denouden – Product Engineer Gregory Thompson – Quality Center Manager Mike Rhode – Resident Engineering Manager Larry Smith - Block Line Team Member Ernie Woda – CMM Lab Chris Brush – Central Engineering Lead, Block Machining Randy Dickerman – Resident Engineer Engine Assembly Deandre Martin – Gage Lab Technician Casey Schiller – Block Line Team Member Todd Palenske – Block Line Team Leader

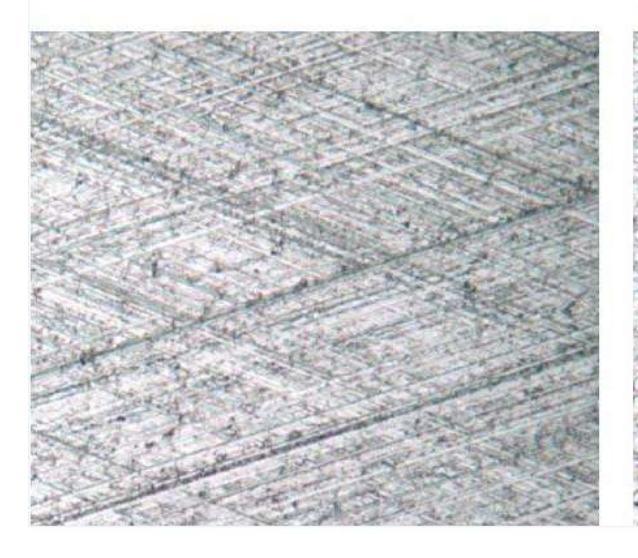
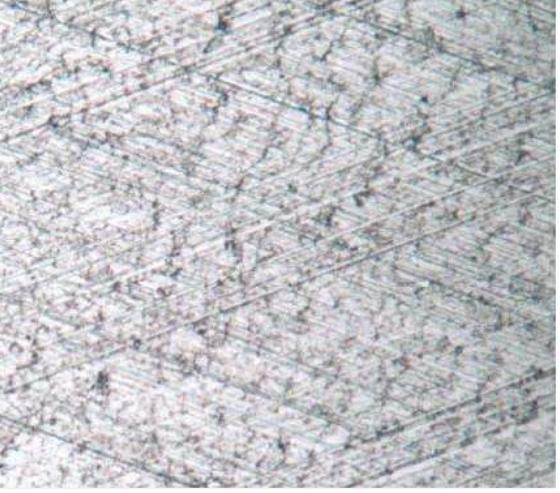
Figure 2 - Example of Good/Bad Comparison for TFM & Crosshatch

Cross hatch clearly visible, no signs of smearing. Quality of the finish is good.

Fax filming is a more qualitative method to obtain data. The images obtained from fax films are very ambiguous in that they can give a visual quality comparison, but no actual numbers or percent TFM can be determined from fax films alone. Fax film is produced in long thin rolls and is also known as acetate paper. Acetone is lightly sprayed on the desired surface and the film is placed on top. A chemical reaction takes place that imprints the cylinder bore surface pattern into the fax film. The fax film cleanly peels off so that it can be analyzed under a microscope (more details on procedure attached separately). Once the fax films have been taken, and microscope images are produced, the images are not only checked for proper and visible crosshatch angle but also topographical signs of smearing or TFM as mentioned and pictured above (Figure 2).

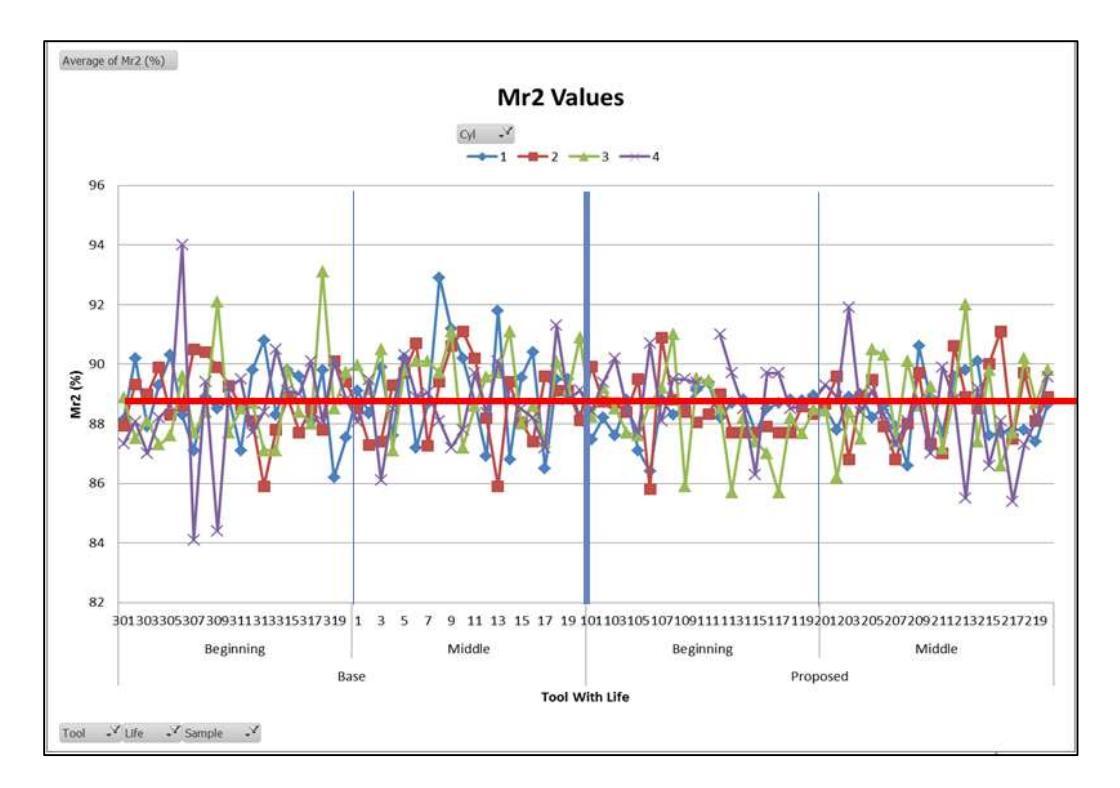
Figure 15 – Mr2 Values

The Rk values in Figure 14 are interesting in that spindle five seems to operate differently than spindle six. Spindle five hones bore's one and two, while spindle six hones bore's three and four. The red and blue data values associated with bores one and two are consistently higher and closer together than the green and purple data values. This confirms some small discrepancies within the machine settings. Mr2 values were continuous and within specification (Figure 15).

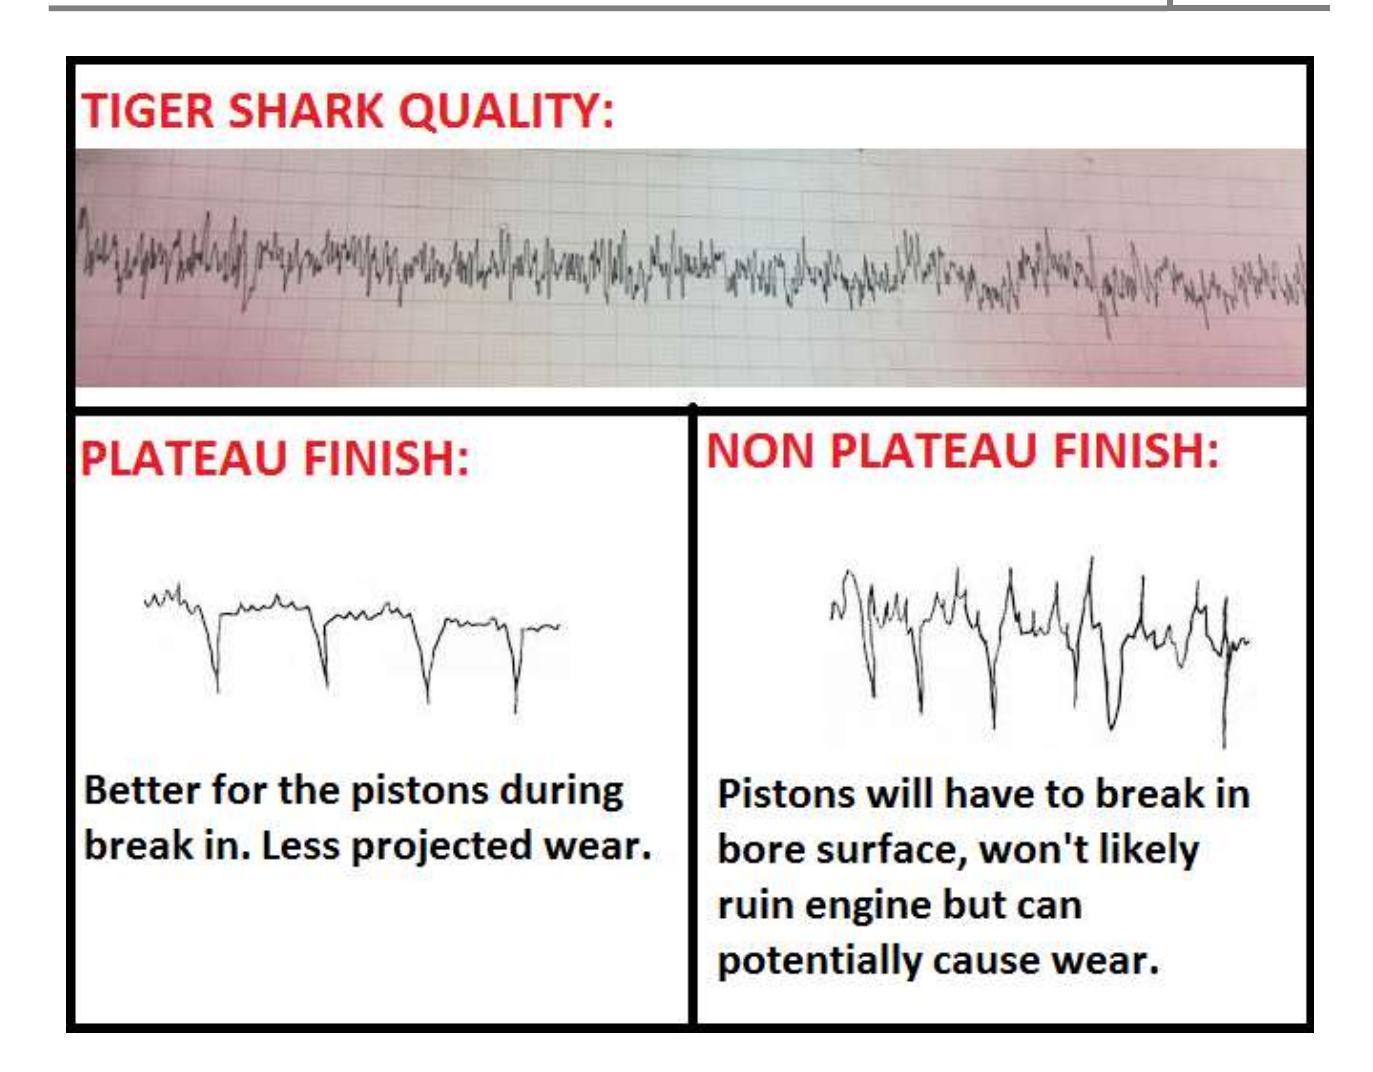
Figure 20 - Surface Finish [3]

Figure 20 reproduces a surface scan on the bores (the cross section of a cylinder bore). The Tiger Shark finish is considered a non-plateau finish. Although a plateau finish is more preferred, it seems from Figure 20 that the valleys are not so deep that excessive oil would be consumed from surface finish alone. The peaks are rough so the piston will end up doing work to break them down, but not likely so much as to create excessive damage. Below are the details associated with the graphical representation of the surface finish.
